Manhole Inspection Summary

Manhole # S31WW1023MH

Insp Date: **1/23/07 1:31 PM**

Location Address: **104 ENFIELD RD**

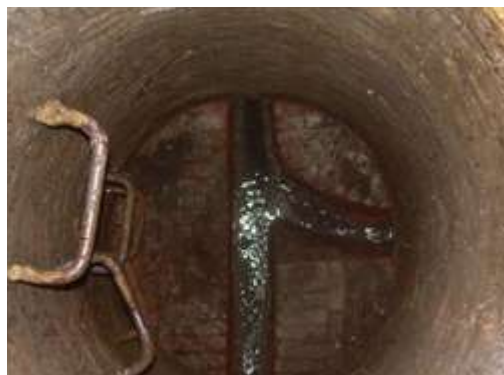
Top View

Corroded steps. Evidence of surcharge - Bench debris.

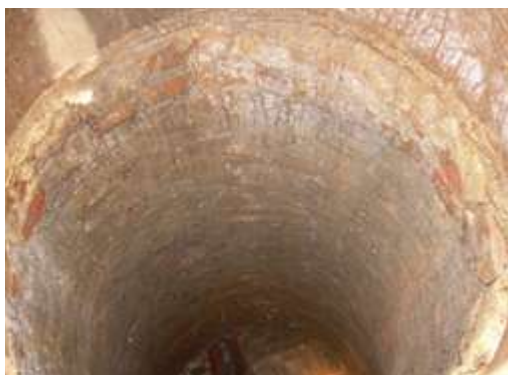
Defect

Frame Offset: **1** (in.) Condition: ☐ Sound ☐ Cracked ☒ **Leaks**

Frame leaks. Adjustment deterioration and infiltration.

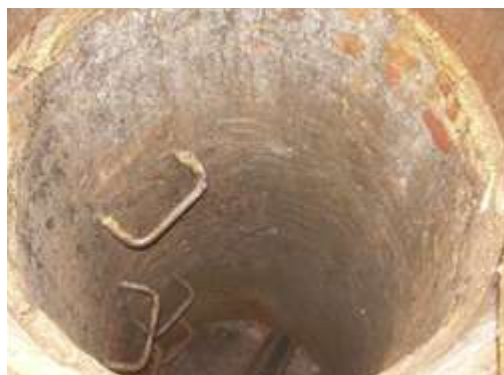
Defect

Condition: ☐ Sound ☐ Cracked ☐ Root Intrusion ☐ Loose Brick ☒ **Deteriorated**

Infiltration: ☐ None ☒ **Joint** ☐ Cracks ☒ **Mortar** ☐ Roots ☐ Wall

Frame leaks. Adjustment deterioration and infiltration.

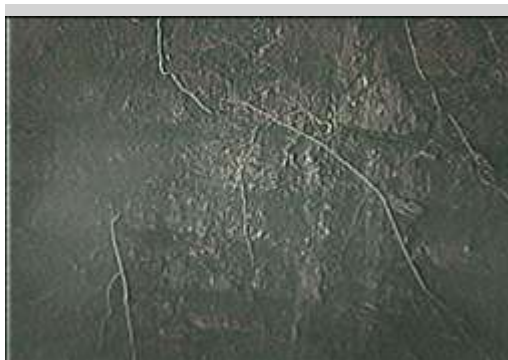
Defect

Condition: ☐ Sound ☐ Cracked ☒ **Root Intrusion** ☐ Loose Brick ☐ Deteriorated

Infiltration: ☐ None ☐ Joint ☐ Cracks ☒ **Mortar** ☒ **Roots** ☐ Wall

Corbel root intrusion and infiltration.

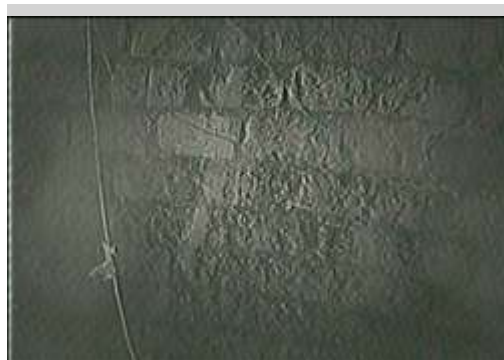
Defect

Condition: ☐ Sound ☐ Cracked ☒ **Root Intrusion** ☐ Loose Brick ☒ **Deteriorated**

Infiltration: ☐ None ☐ Joint ☐ Cracks ☒ **Mortar** ☒ **Roots** ☐ Wall

Barrel deterioration, root intrusion and infiltration.

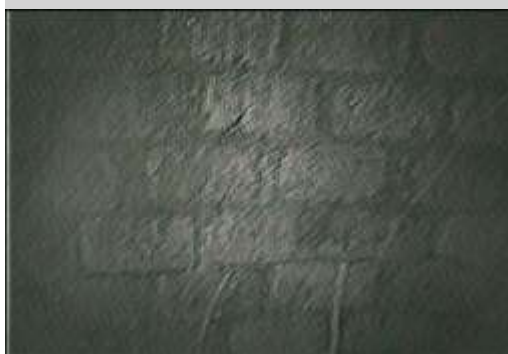
Defect

Corbel root intrusion and infiltration.

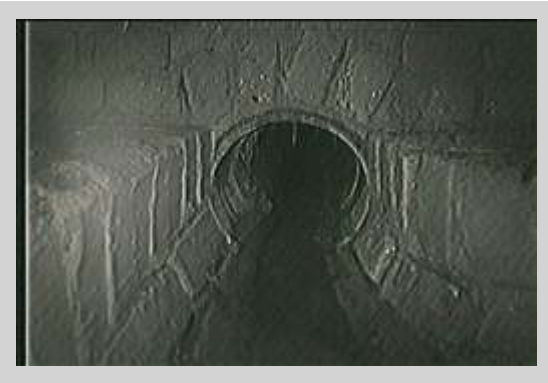
8 in. Circular Gravity Sewer Pipe Out @ 12 O'Clock

Channel deterioration.

Infiltration: **Evidence** Pipe Seal Cond: **Unknown**

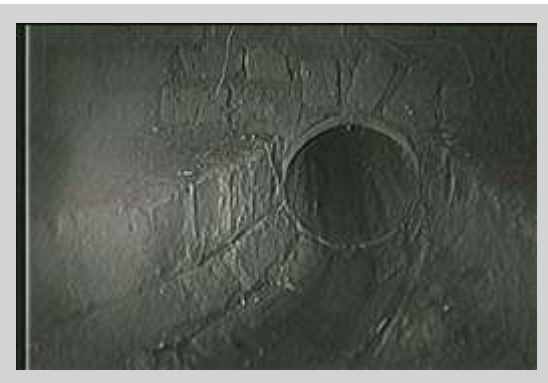
8 in. Circular Gravity Sewer Pipe In @ 3 O'Clock

Barrel deterioration, root intrusion and infiltration.

Infiltration: **None** Pipe Seal Cond: **Cracked**

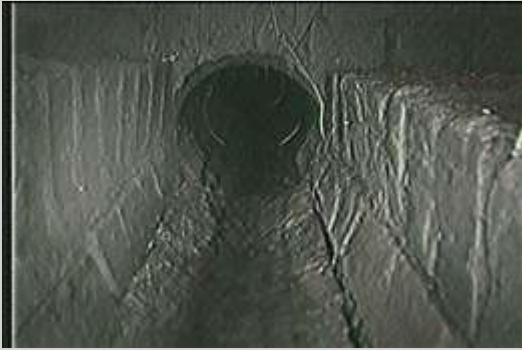
Pipe In @ 6 O'Clock

Channel deterioration.

Infiltration: **Evidence** Pipe Seal Cond: **Unknown**
